Project Development & Environment (PD&E) Study For SR 9/I-95 @ Northlake Boulevard Interchange In Palm Beach County

Cultural Resources Assessment Survey

FM No: 435803-1-22-02

Florida Department of Transportation | District IV

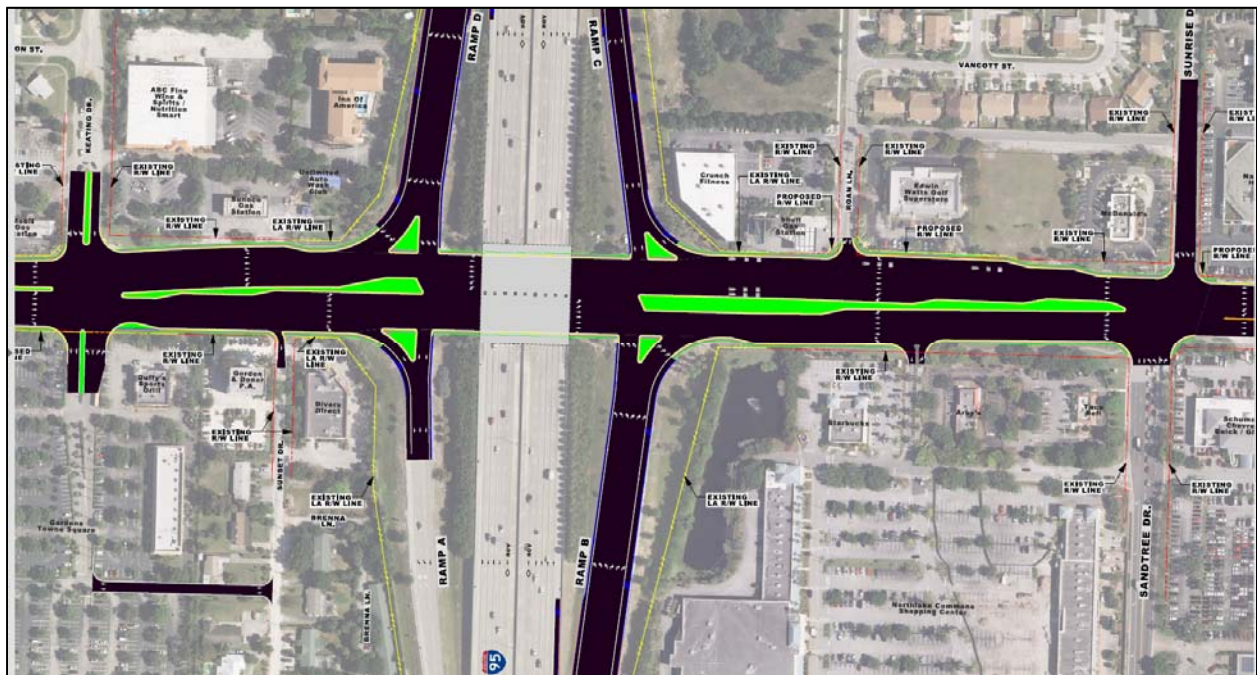
- Northlake Boulevard will have one additional lane for eastbound traffic from west of Keating Drive to Sandtree Drive to maintain traffic flow through the I-95 terminals.

- Northlake Boulevard will have one additional lane for westbound traffic from west of Keating Drive to east of Sandtree Drive to maintain traffic flow through the I-95 terminals.
- At Sunset Drive, closure of the northbound right turn should be considered to reduce vehicle conflicts. Access from Sunset Drive to Keating Drive through the shopping center and right of way and joint-use agreements should be considered during the design and right of way phase.
- At Roan Lane the eastbound left turn, median opening and traffic signal is removed.

Figure 2-2 Alternative 1: Modified Concept Interchange (Interchange Detail)

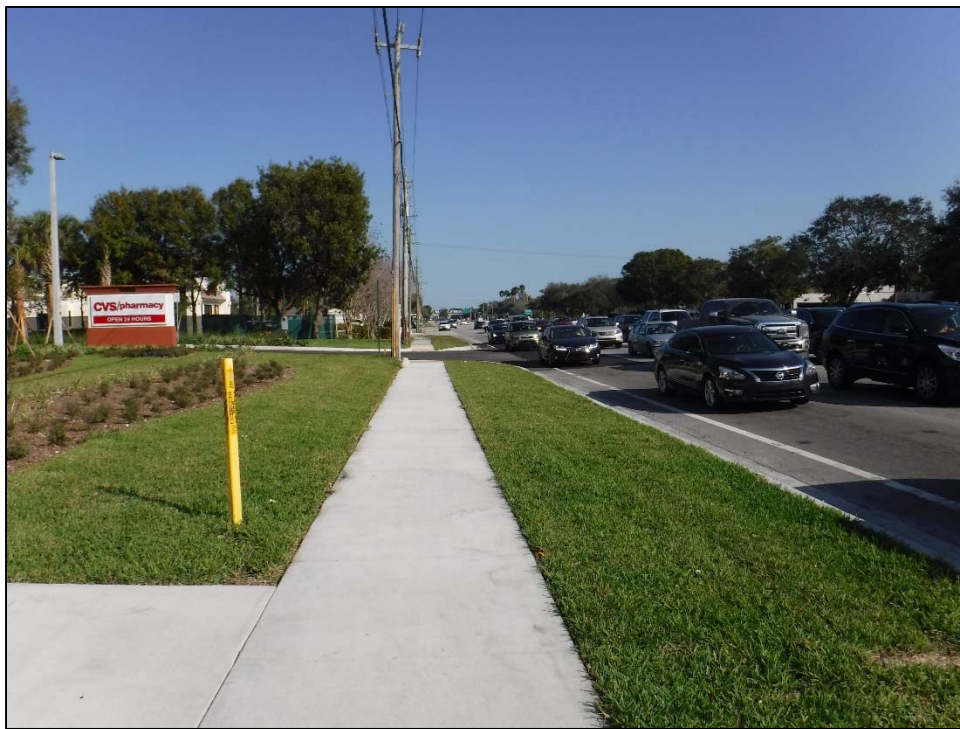
Figure 10-1 North Side of Northlake Boulevard from the Intersection with Military Trail, Showing Landscaping, Hardscape, and Buried and Overhead Utilities Within the ROW, Facing East

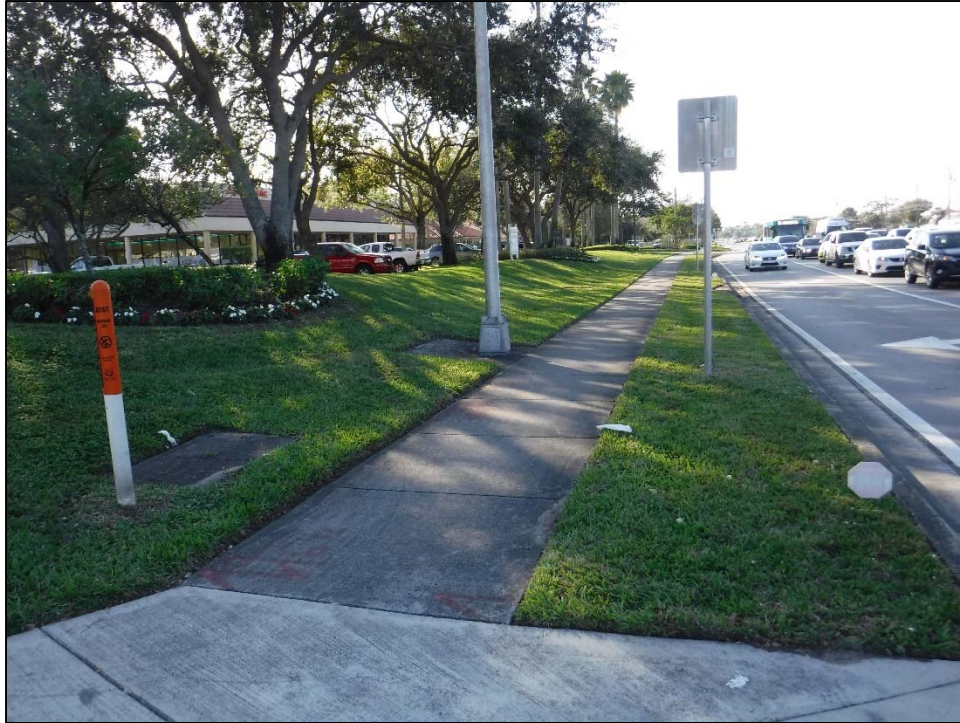
Figure 10-2 South Side of Northlake Boulevard from the Intersection with Keating Drive, Showing Landscaping, Hardscape, and Buried and Overhead Utilities Within the ROW, Facing West

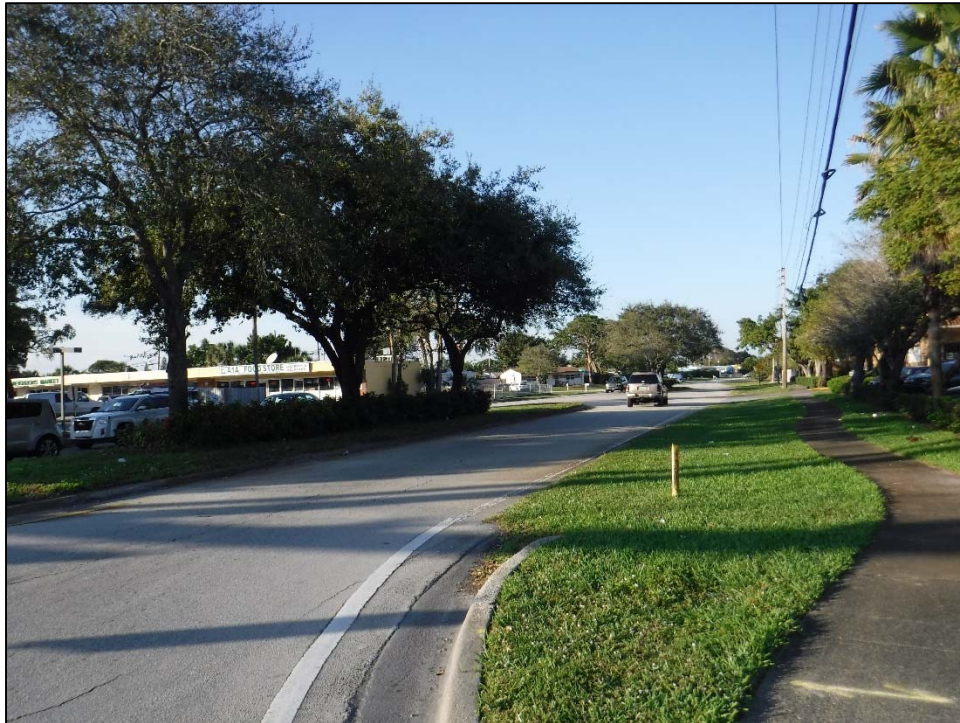
Figure 10-3 East Side of Keating Drive from Northlake Boulevard, Showing Landscaping, Hardscape, and Buried and Overhead Utilities Within the ROW, Facing North Northwest

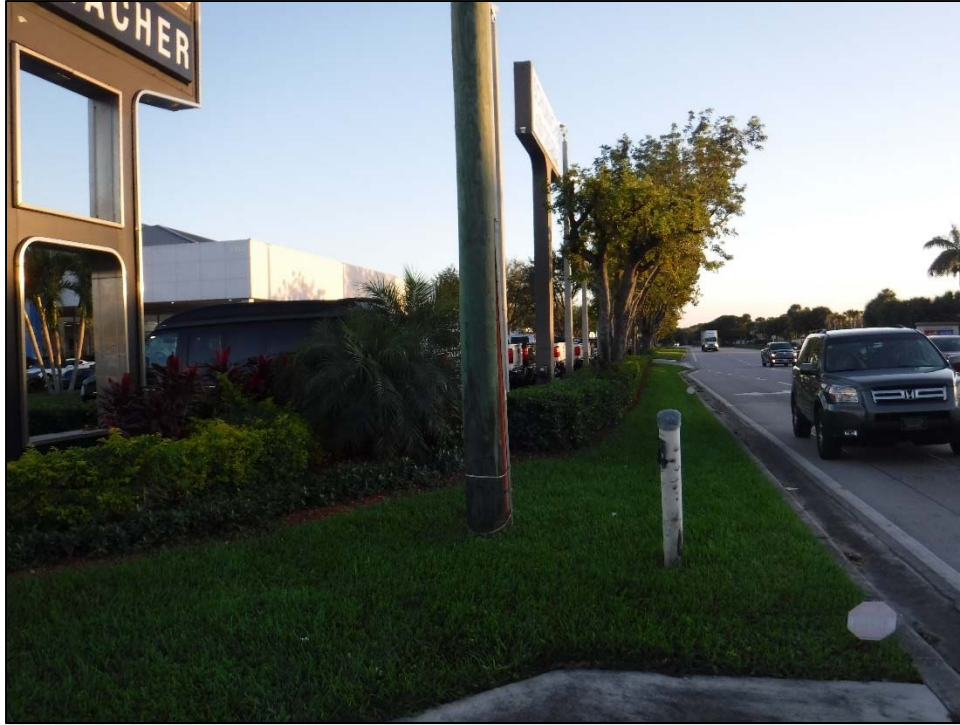
Figure 10-4 East Side of Sandtree Drive at Northlake Boulevard, Showing Landscaping, Hardscape, and Buried Utilities Within the Area of Proposed ROW Acquisition, Facing South

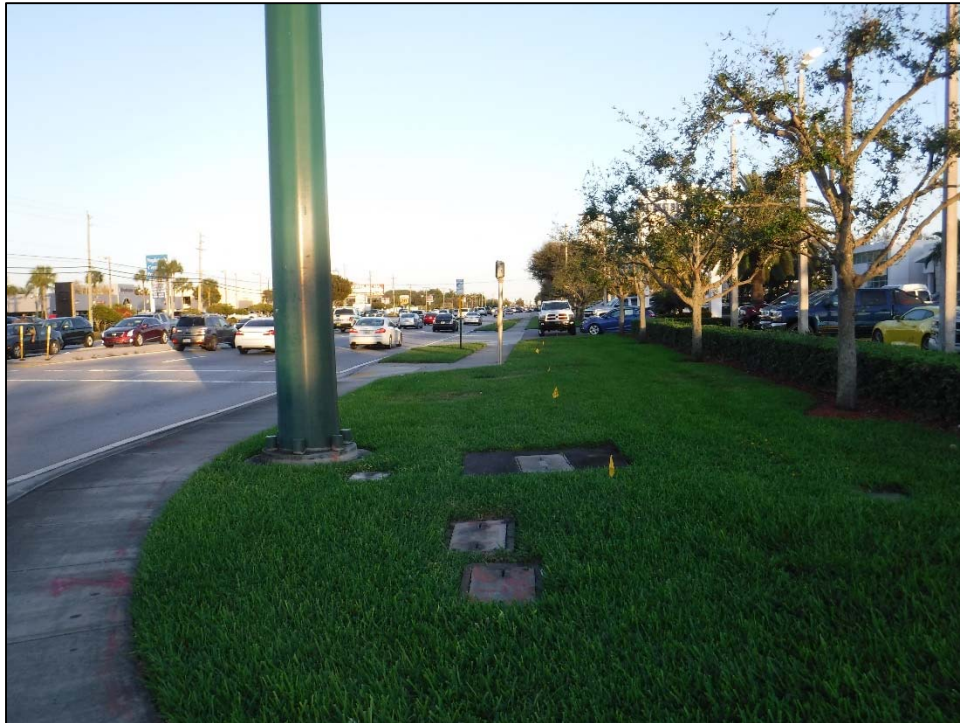
Figure 10-5 South Side of Northlake Blvd at Sandtree Drive, Showing Landscaping, Hardscape, and Buried and Overhead Utilities Within the ROW, Facing East

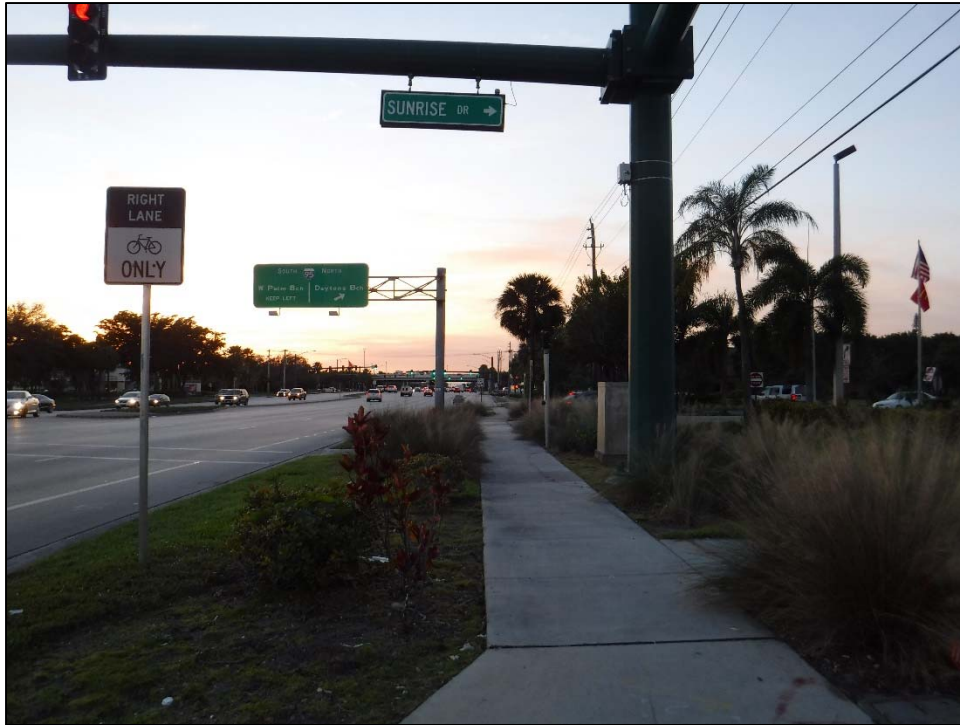
Figure 10-6 North Side of Northlake Blvd from the Intersection with Sunrise Drive, Showing Landscaping, Hardscape, and Buried and Overhead Utilities within the ROW, Facing West

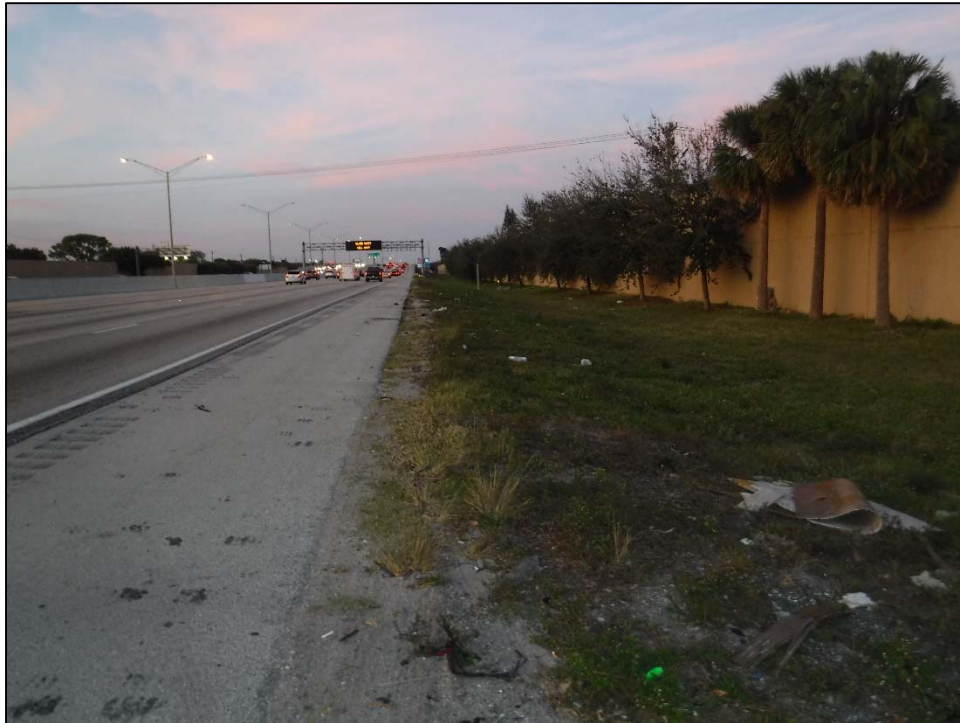
Figure 10-7 East Side of SR 9/I-95 from Earman River Canal, Showing Ditch and Berm Construction, Sound Wall, Landscaping, Hardscape, and Buried Utilities within the ROW, Facing North

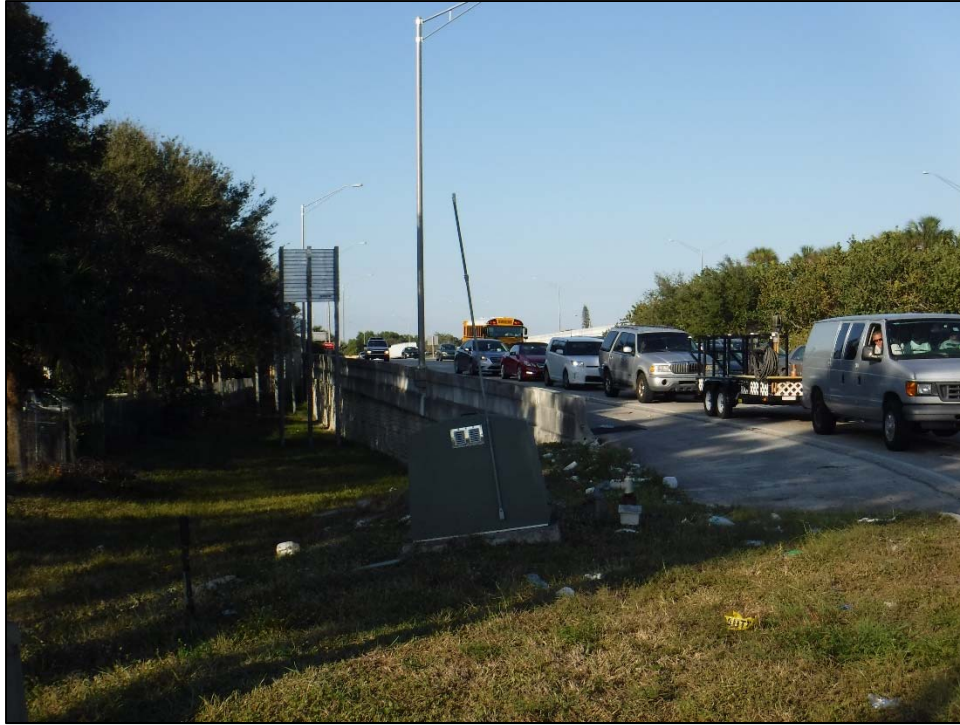
Figure 10-8 West Side of SR 9/I-95 Southbound Off-Ramp, Showing Ditch and Berm Construction, Landscaping, Hardscape, and Buried Utilities within the ROW, Facing North Northeast

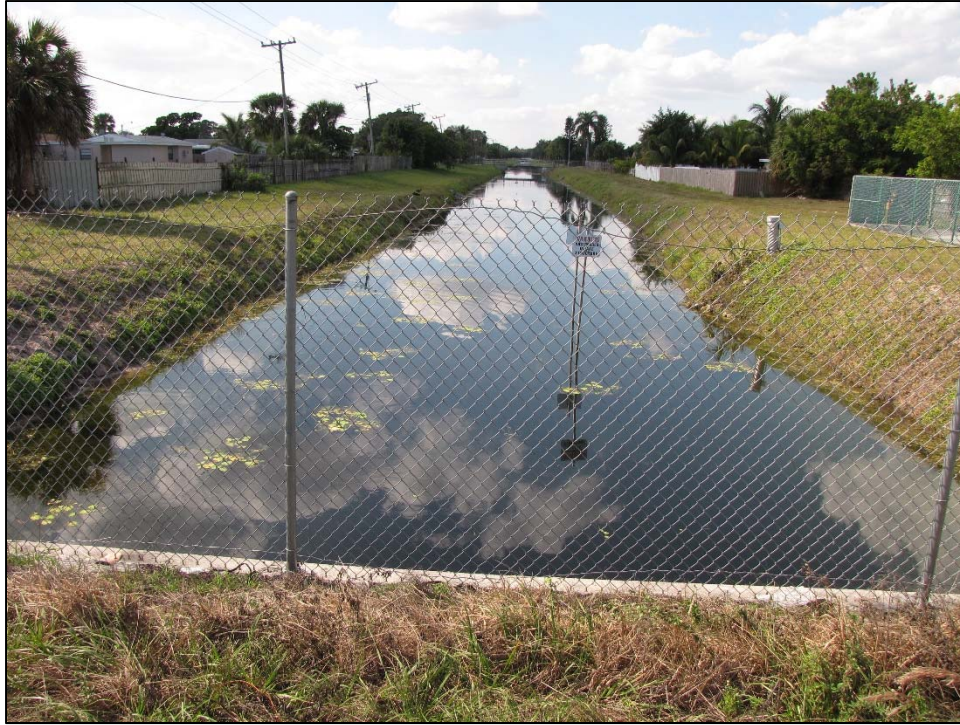
8PB16286 **Earman River Canal Branch**

Figure 10-12 Earman River Canal Branch (8PB16286), Considered National Register-Ineligible, Facing East

The Earman River Canal Branch (8PB16286) is a common canal type constructed in connection with mid-century residential development of Palm Beach Gardens (**Figure 10-12**). It was determined National Register–ineligible by the SHPO in 2016.

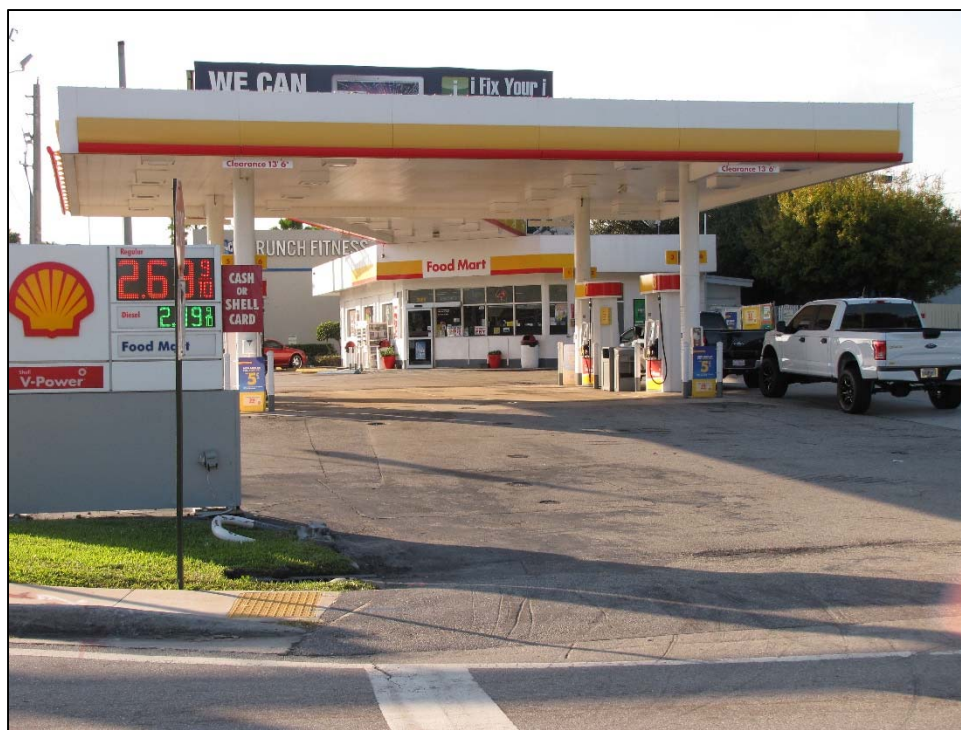
8PB17044 Shell Gas Station and Food Mart/3905 Northlake Boulevard

Figure 10–13 Shell Gas Station and Food Mart/3905 Northlake Boulevard (8PB17044), Considered National Register-Ineligible, Facing West

Shell Gas Station and Food Mart/3905 Northlake Boulevard (8PB17044) is a circa-1968 one-story Masonry Vernacular building with a concrete foundation, built-up flat roof, and replacement glass and metal windows and door (**Figure 10–13**). Exterior ornamentation includes textured stucco, molded stucco quoins, and overhanging eaves. A shed roof storage addition has been added to the north façade of the building. This gas station has also been updated with new gas pumps covered with a flat roof canopy with concrete supports, and a flat roof unsupported canopy connecting gas pumps with the main structure. This building is an example of common Masonry Vernacular-style commercial buildings found throughout South Florida and does not possess sufficient historical or architectural significance to be considered individually eligible for inclusion in the National Register under Criteria A, B, C, or D. Furthermore, it has sustained non-historic modifications that compromise its integrity.

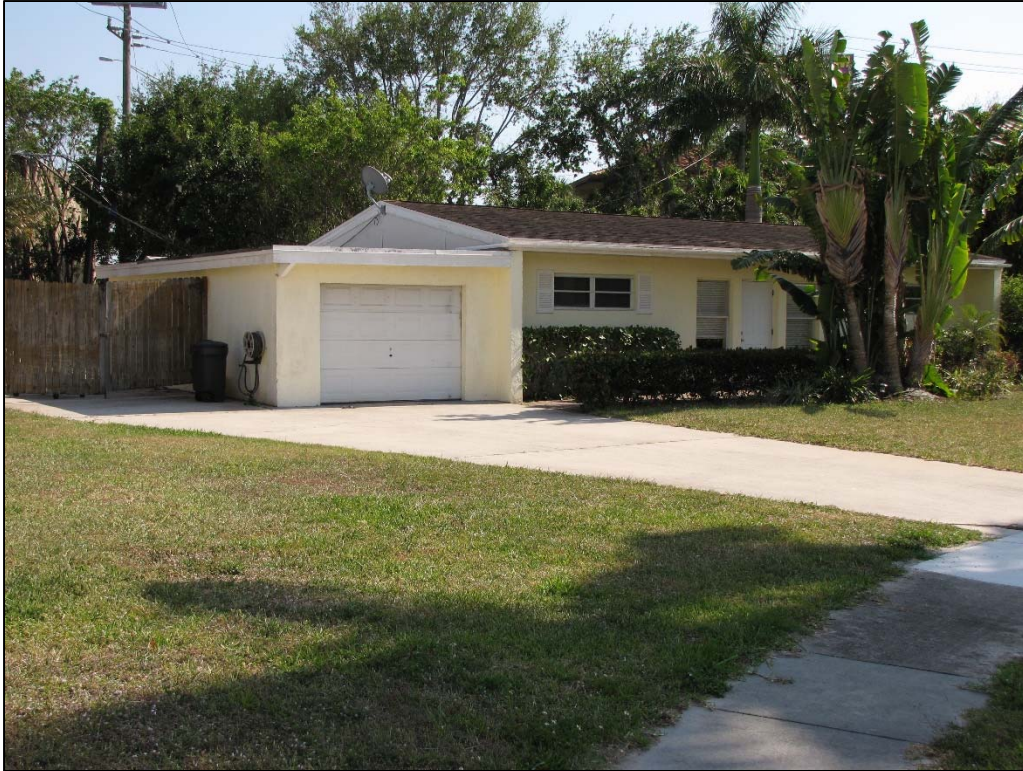
8PB17104 4058 Rochester Street

Figure 10-14 4058 Rochester Street (8PB17104), Considered National Register–Ineligible, Facing South

The Masonry Vernacular style residence located at 4058 Rochester Street (8PB17104) was constructed circa-1960 and features a side gable roof portion and west flat roof portion containing a one-bay parking garage (**Figure 10-14**). Walls are clad in a stucco treatment. Windows are original aluminum one-over-one single-hung sash. Those windows that flank the replacement panel door at the west façade are floor-to-ceiling. This residence is of common design and style found throughout South Florida and does not possess sufficient historical or architectural significance to be considered individually eligible for inclusion in the National Register under Criteria A, B, C, or D. It is located in the Palm Beach Square neighborhood, which is not considered a National Register–eligible historic district due to a lack of historical and architectural significance.

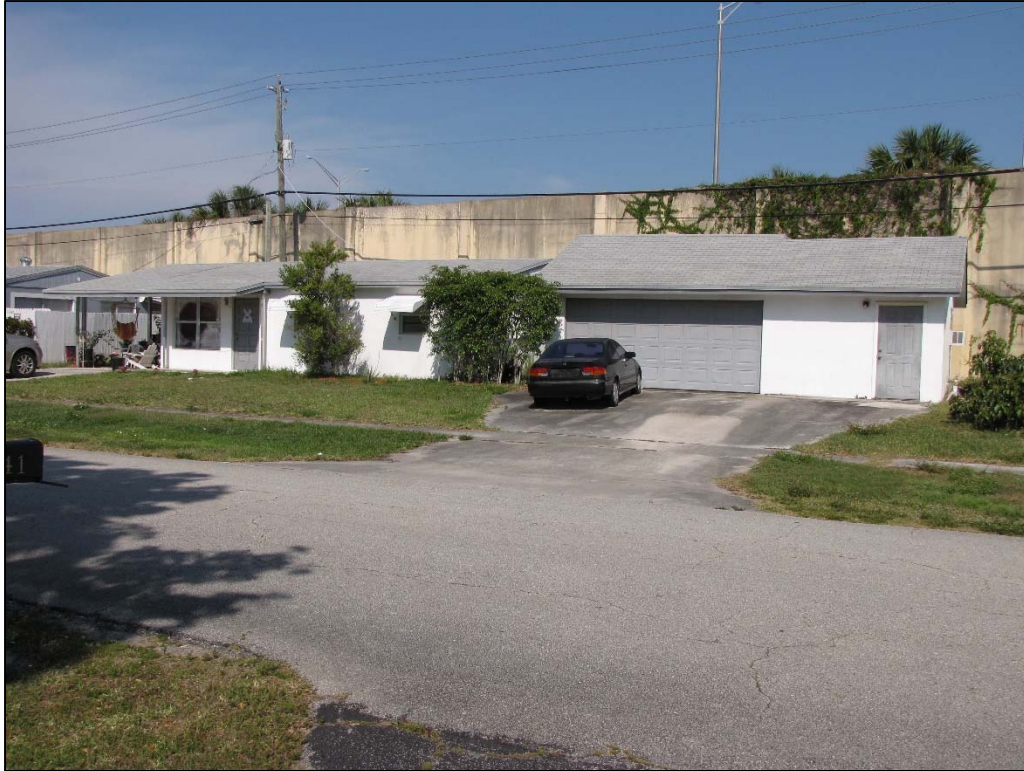
8PB17105 9152 Birmingham Drive

Figure 10-15 9152 Birmingham Drive (8PB17105), Considered National Register–Ineligible, facing Northeast

The Masonry Vernacular style residence located at 9152 Birmingham Drive (8PB17105) was constructed circa-1960 (**Figure 10-15**). An entrance porch is set beneath an extension of the main side gable roof at the west façade; a wood panel door accesses the house from this porch. Walls are clad in a stucco treatment. Windows are original aluminum one-over-one single-hung sash. A large two-bay gable roof garage was appended to the south wall of the house circa-1986. This building is an example of common design and style found throughout South Florida and does not possess sufficient historical or architectural significance to be considered individually eligible for inclusion in the National Register under Criteria A, B, C, or D. Furthermore, it has sustained non-historic modifications that compromise integrity. It is located in the Palm Beach Square neighborhood, which is not considered a National Register–eligible historic district due to a lack of historical and architectural significance.

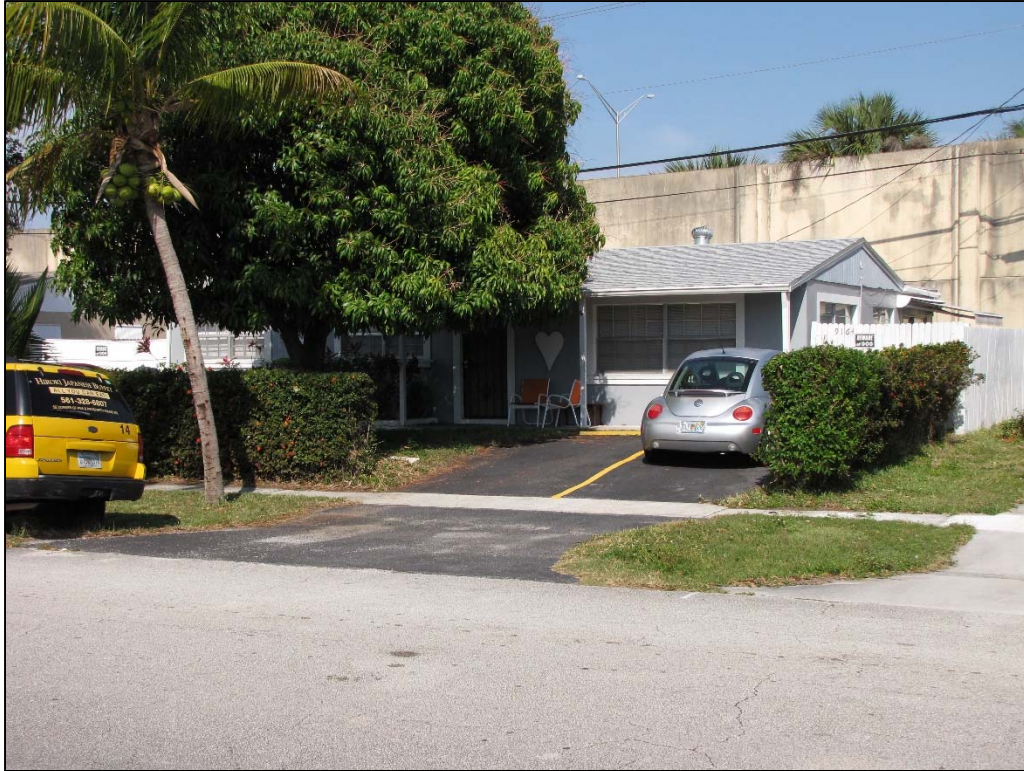
8PB17106 9164 Birmingham Drive

Figure 10-16 9164 Birmingham Drive (8PB17106), Considered National Register–Ineligible, Facing Northeast

The Masonry Vernacular style residence located at 9164 Birmingham Drive (8PB17106) was constructed circa-1960 and features a side gabled roof system with an east flat roof extension (**Figure 10-16**). Walls are clad in a stucco treatment. A slight roof extension at the west façade incorporates the main entrance porch, which features simple rectangular wood supports and a replacement panel door. Windows are replacement aluminum six-over-six single-hung sash. A one-bay carport has been enclosed at the north end of the house. This building is an example of common design and style found throughout South Florida and does not possess sufficient historical or architectural significance to be considered individually eligible for inclusion in the National Register under Criteria A, B, C, or D. Furthermore, it has sustained non-historic modifications that compromise integrity. It is located in the Palm Beach Square neighborhood, which is not considered a National Register–eligible historic district due to a lack of historical and architectural significance.

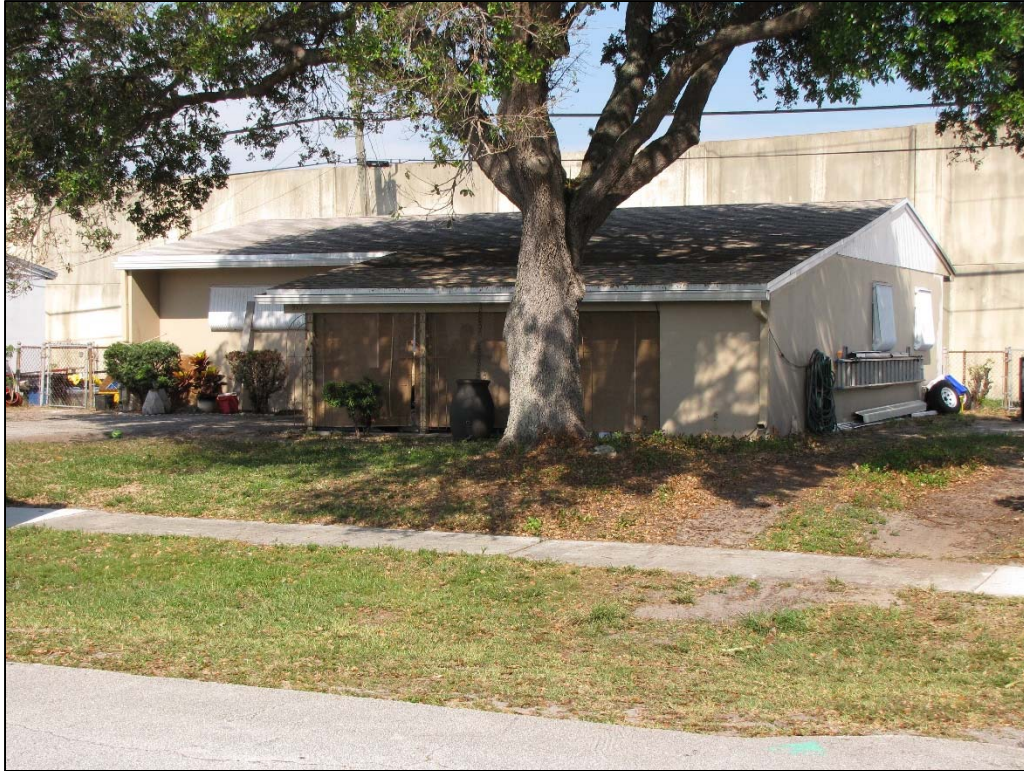
8PB17107 9176 Birmingham Drive

Figure 10-17 9176 Birmingham Drive (8PB17107), Considered National Register–Ineligible, facing Northeast

This Masonry Vernacular style residence (8PB17107) was constructed circa-1960 and features a side gabled roof portion and west façade roof extension one-bay carport supported by metal poles (**Figure 10-17**). Beneath the carport roof line is a utility room. Walls are clad in a stucco treatment. The house is accessed by a simple wood door from within the carport. Window configurations were obscured by operable metal awnings at the time of the survey. This building is an example of common design and style found throughout South Florida and does not possess sufficient historical or architectural significance to be considered individually eligible for inclusion in the National Register under Criteria A, B, C, or D. It is located in the Palm Beach Square neighborhood, which is not considered a National Register–eligible historic district due to a lack of historical and architectural significance.

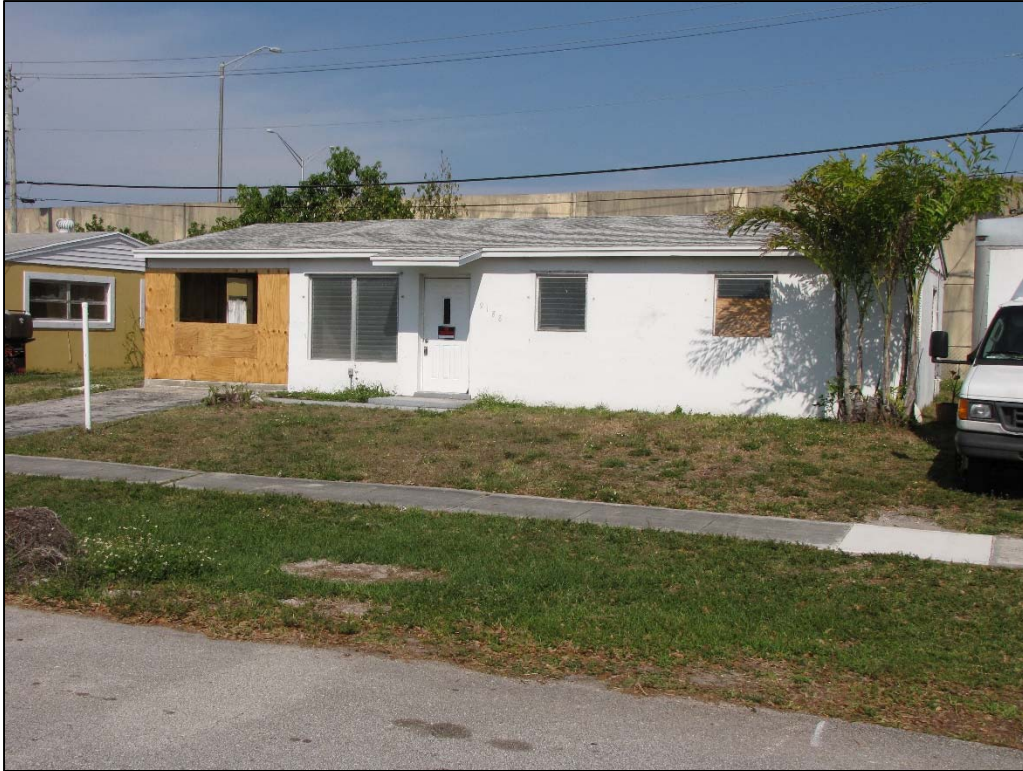
8PB17108 9188 Birmingham Drive

Figure 10-18 9188 Birmingham Drive (8PB17108), Considered National Register–Ineligible, Facing Northeast

This Masonry Vernacular style residence (8PB17108) was constructed circa-1960 and features a side gabled roof system and slight west façade roof extension that shelters the main entrance stoop (**Figure 10-18**). The main entrance door is wood panel with a single rectangular inset light. Walls are clad in a stucco treatment. Windows are multi-light jalousie. The integral carport at the north end of the building was in the process of being enclosed at the time of the survey. This building is an example of common design and style found throughout South Florida and does not possess sufficient historical or architectural significance to be considered individually eligible for inclusion in the National Register under Criteria A, B, C, or D. Furthermore, it has sustained non-historic modifications that compromise its integrity. It is located in the Palm Beach Square neighborhood, which is not considered a National Register–eligible historic district due to a lack of historical and architectural significance.

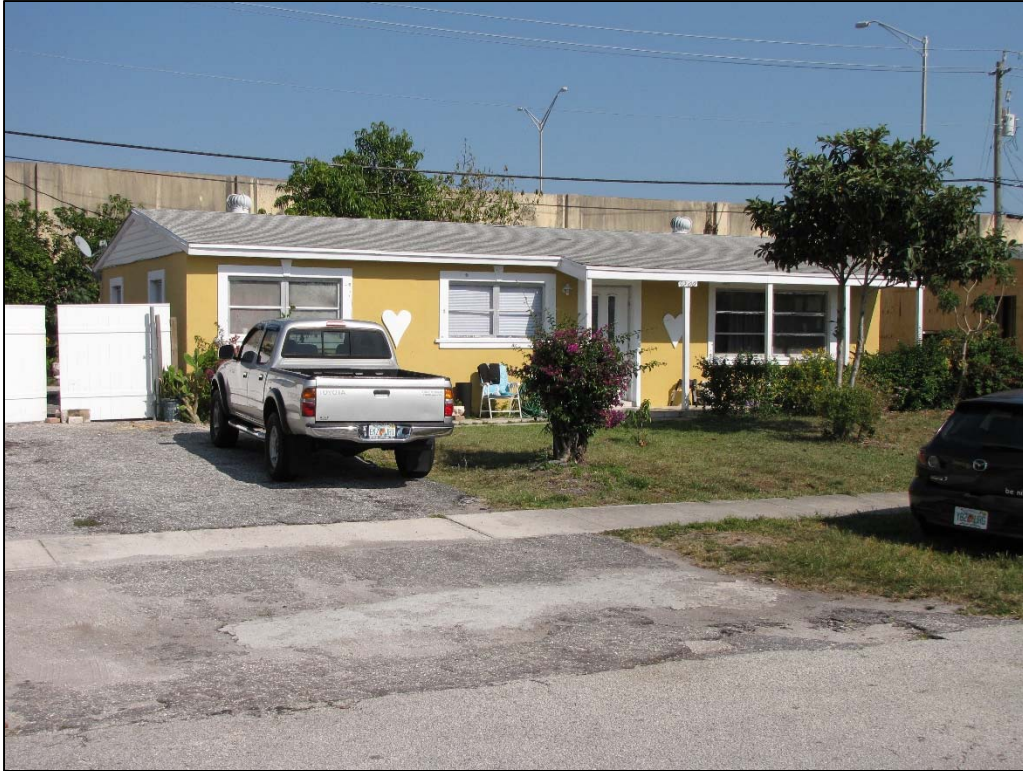
8PB17109 9200 Birmingham Drive

Figure 10-19 9200 Birmingham Drive (8PB17109), Considered National Register–Ineligible, Facing Southeast

This Masonry Vernacular style residence (8PB17109) was constructed circa-1960 and features a side gable roof portion and west façade roof extension porch with simple rectangular wood supports and a wood panel door with rectangular inset lights (**Figure 10-19**). Two flat roof additions have been appended to an original flat roof extension at the east. Walls are clad in a stucco treatment. Windows are replacement aluminum one-over-one single-hung sash. A carport has been enclosed at the north end of the house. This building is an example of common design and style found throughout South Florida and does not possess sufficient historical or architectural significance to be considered individually eligible for inclusion in the National Register under Criteria A, B, C, or D. Furthermore, it has sustained non-historic modifications that compromise its integrity. It is located in the Palm Beach Square neighborhood, which is not considered a National Register–eligible historic district due to a lack of historical and architectural significance.

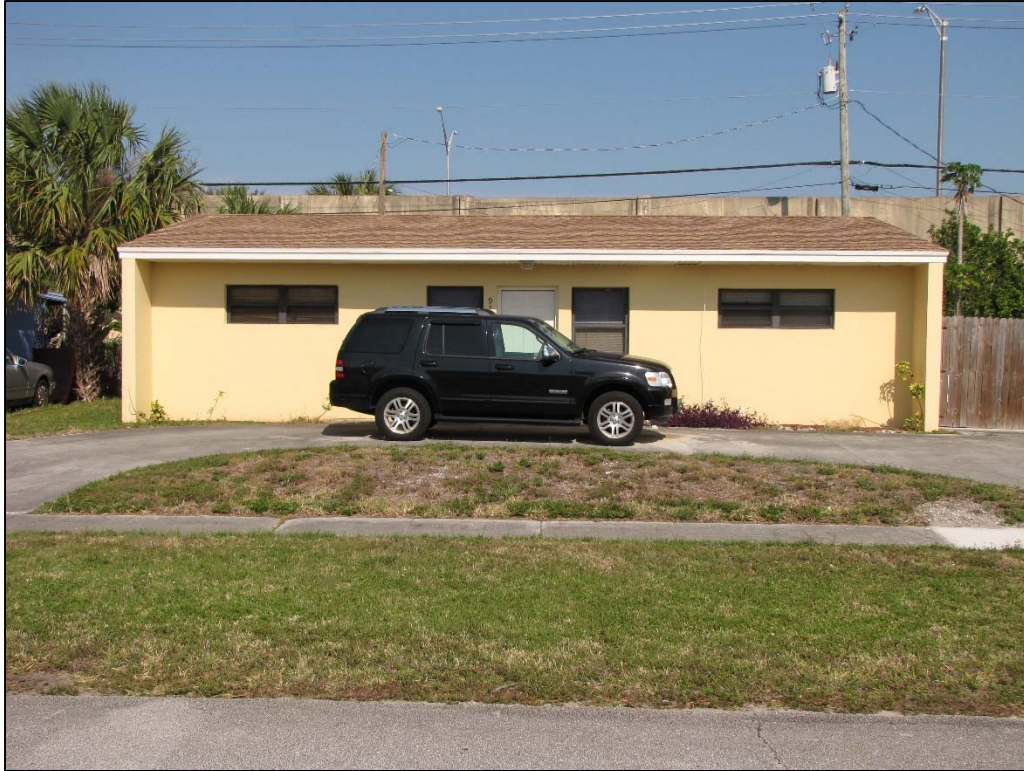
8PB17110 9212 Birmingham Drive

Figure 10-20 9212 Birmingham Drive (8PB17110), Considered National Register–Ineligible, Facing East

This Masonry Vernacular style residence (8PB17110) was constructed circa-1960 and features a side gable roof system (**Figure 10-20**). Walls are clad in a stucco treatment. The west façade is recessed and boxed-in to shade the main entrance; a replacement panel door is centrally set within the façade. Windows are replacement metal one-over-one single hung sash. This building is an example of common design and style found throughout South Florida and does not possess sufficient historical or architectural significance to be considered individually eligible for inclusion in the National Register under Criteria A, B, C, or D. It is located in the Palm Beach Square neighborhood, which is not considered a National Register–eligible historic district due to a lack of historical and architectural significance.

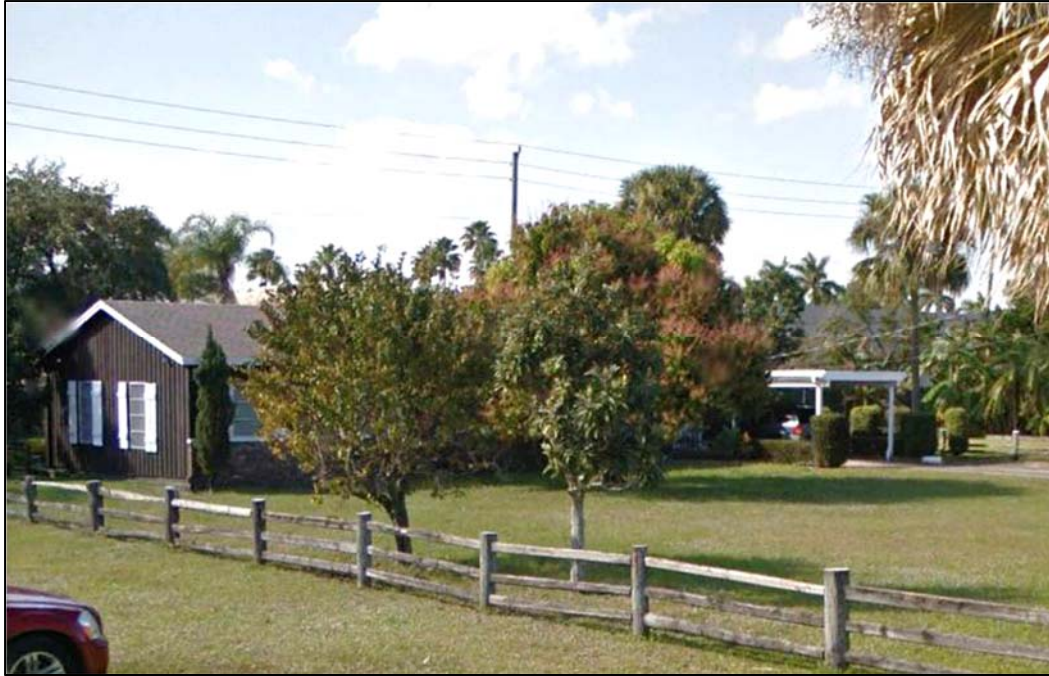
8PB17111 8941 Sunset Drive

Figure 10-21 8941 Sunset Drive (8PB17111), Considered National Register–Ineligible, facing Northwest (Image Courtesy of Google Earth)

This Frame Vernacular style residence (8PB17111) was constructed circa-1950 and features original side gable roof portions at the north and an east front gable roof extension entrance porch (**Figure 10-21**). Further details of this porch were obscured by landscaping. By 1969, gable roof additions and a flat roof rear porch were appended to the south wall of the residence. After 1969, a flat roof porch extension and carport were constructed at the east façade. Walls are clad in vertical wood siding. Windows are replacement aluminum four-light awning. This building is an example of common design and style found throughout South Florida and does not possess sufficient historical or architectural significance to be considered individually eligible for inclusion in the National Register under Criteria A, B, C, or D. Furthermore, it has sustained non-historic modifications that compromise its integrity. It is located in an area that lacks sufficient concentrations of historic resources to be considered a National Register–eligible historic district.

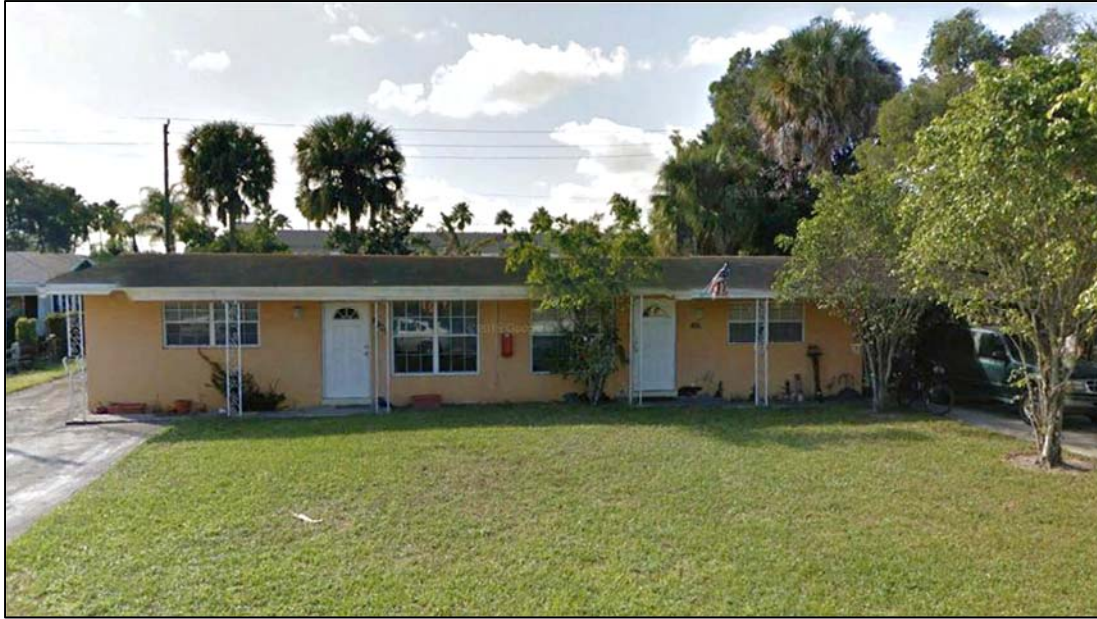
8PB17112 8909 Sunset Drive

Figure 10-22 8909 Sunset Drive (8PB17112), Considered National Register–Ineligible, Facing West
(Image Courtesy of Google Earth)
